WASHINGTON STORAGE STRUCTURES - WHAT ARE THEY LIKE?

by
Henry Waelti, Ralph P. Cavalieri, and Marvin J. Pitts¹

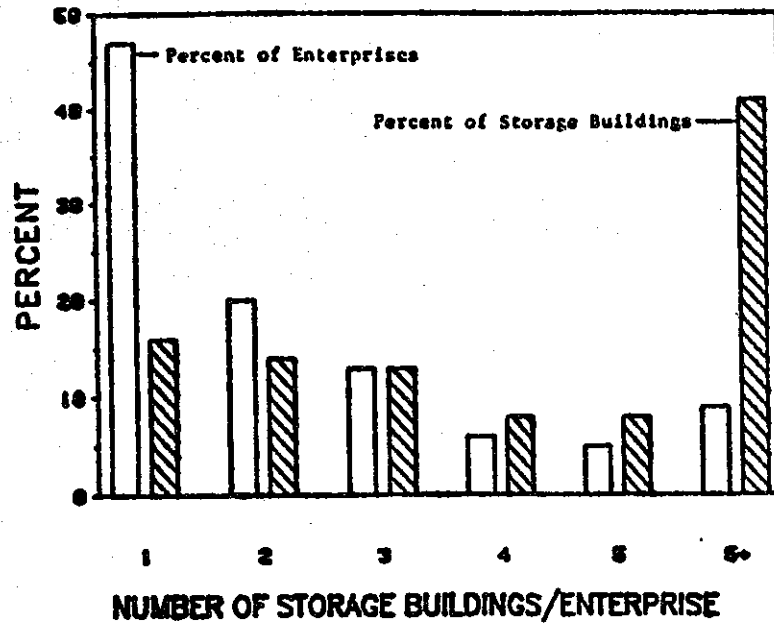
Figure 1. Enterprise size distribution and the percentage of storage buildings represented by each enterprise size.

Two thirds of the enterprises are small (controlling one or two storages), the largest enterprises with 5 or more buildings, comprise about half of the storage buildings. Figure 1 illustrates the enterprise size distribution.

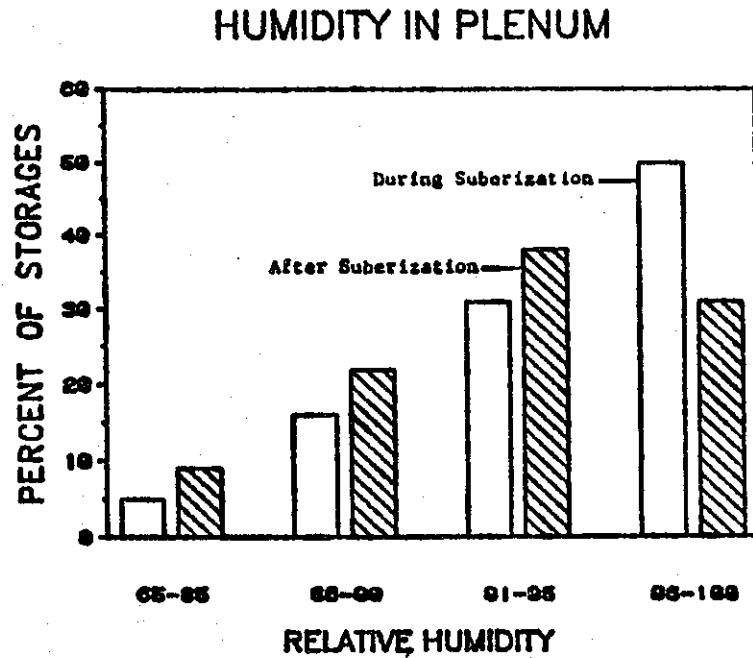
Figure 2. Relative humidity levels in the plenum during suberization and after suberization. The average humidity level during suberization is 94.8% and after suberization, 91.1%.

Relative humidity levels measured in the plenum are shown in Figure 2. The average RH during suberization is 94.8%, ranging from 65% to 100%. During long term storage the average humidity level is reduced to 91.1%, with a range of 60 to 100%. Only 5% of the storage operators maintain an RH below 86% during suberization, and only 10% maintain an RH below 86% during long-term storage.

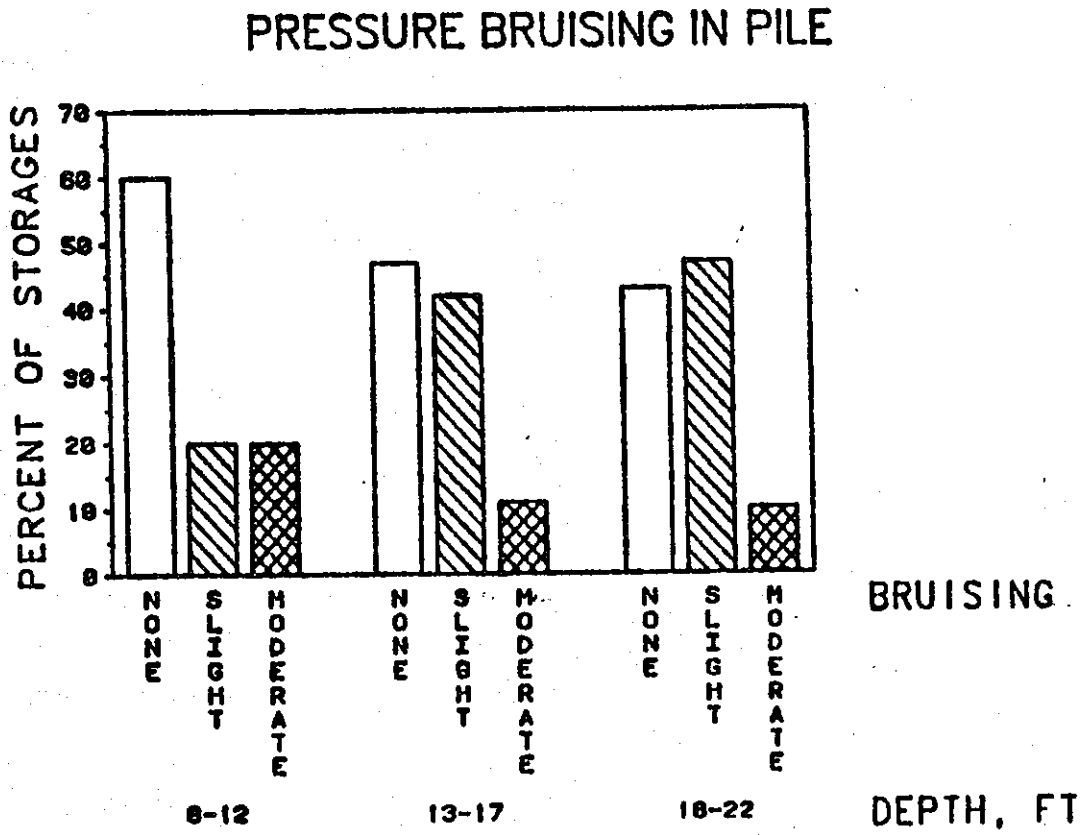
Figure 4. Pressure bruising for three different pile depth levels.

Pile depth did not seem to be a major factor in pressure bruising as illustrated in Figure 4. Slight and moderate bruising occurs in all depth ranges (8-12 ft), (13-17 ft), and (18-22 ft). However, there is a trend of decreasing pressure bruising with increased humidity levels.
